Monitoring Completed Navigation Projects (MCNP) Program

Marmet Locks and Dam, Kanawha River, West Virginia

Final report

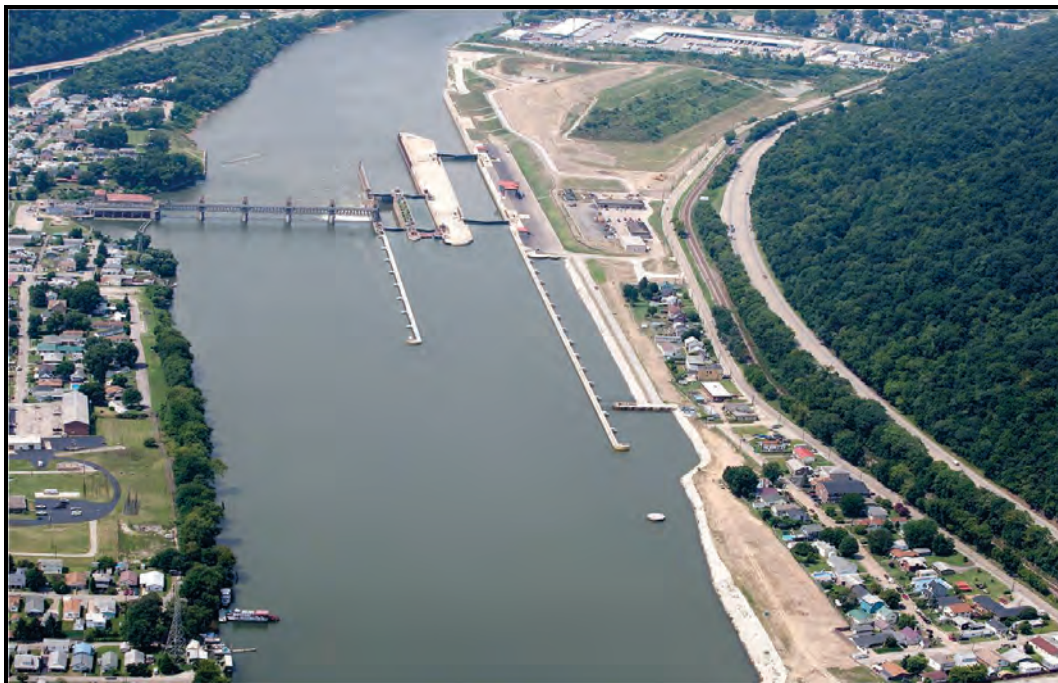
Figure 2. Marmet Locks and Dam, Kanawha River, WV.

The project consists of the new 110 ft by 800 ft lock, the two original 56 ft by 360 ft locks, a non-navigable gated dam, and a 3-unit hydroelectric power plant (Figure 2). The dam is 557 ft long and consists of five roller-type gates, each of which spans 100 ft between concrete piers. The power plant is owned by Kanawha Valley Power Company and is capable of producing 144,000 kilowatts. The new lock is located on the east side of the old locks and has a design lift of 24.0 ft. This condition occurs with a normal upper pool elevation (el) of 590 ft and a normal lower pool el of 566 ft. The new lock features a through-the-sill intake, a longitudinal in-chamber filling and emptying system, and a conventional sidewall discharge manifold in the lower lock approach. In addition, when the new lock was replaced, the upper and lower guide walls were replaced.

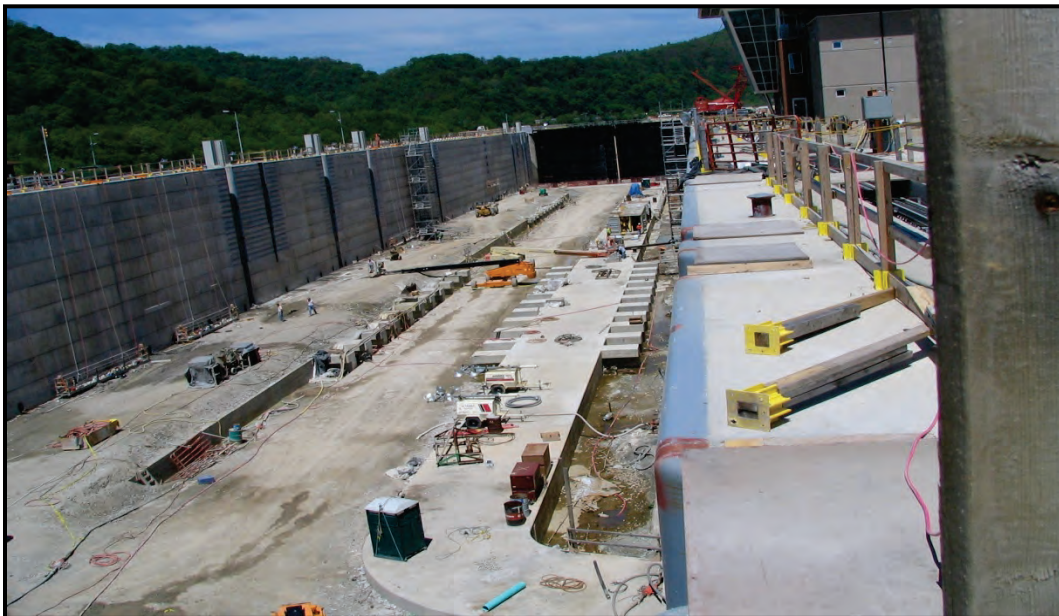
Figure 5. Marmet Lock in-chamber longitudinal culvert system during construction.

A schematic of the Marmet Lock filling and emptying system is shown in Figure 3. The under-the-sill filling system is shown in Figure 4 during construction, also showing the trash racks to prevent driftwood and debris from entering the culvert system. The entire in-chamber culvert system is shown in Figure 5 during construction.

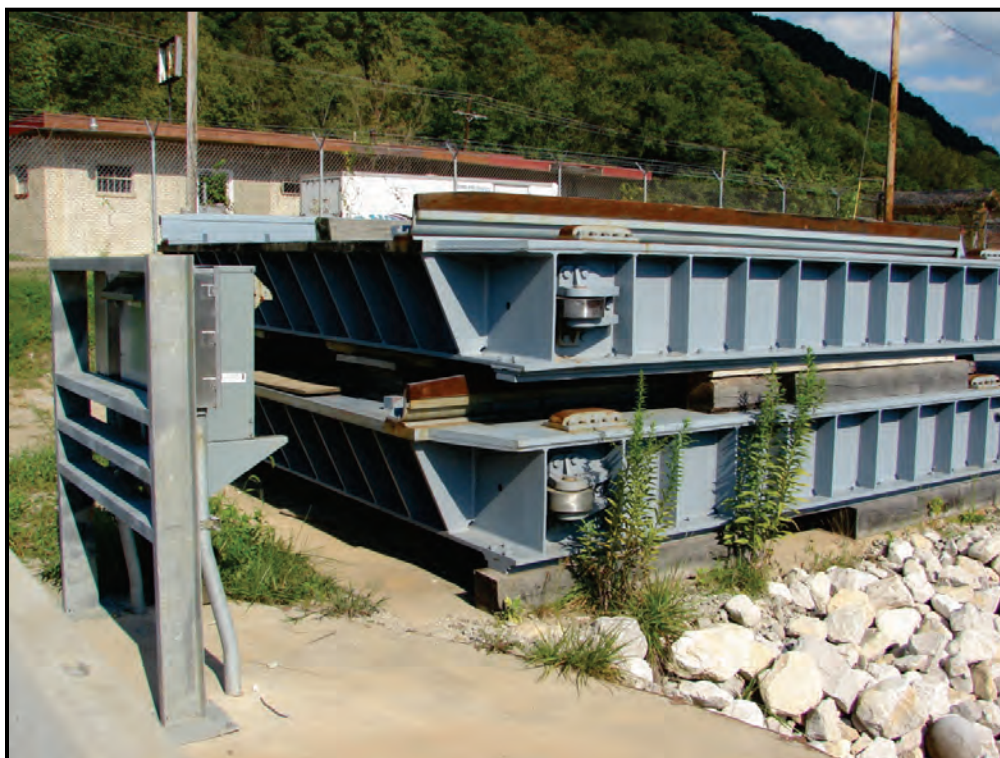
Figure 6. Two spare vertical-lift Stoney gate valves stored at Marmet Locks and Dam.

Stoney gate valves are vertical gates and are not uncommon (the old Marmet Locks have them as well), but the ones used in the new lock are large (13 ft wide by 15 ft high), and there is some concern about how they will perform over a long time period. Figure 6 shows two, spare Stoney gate valves that are stored on the right bank adjacent to the upstream guide wall. Figure 7 shows the machined seal on the bottom of the gate valve. Figure 8 shows the mechanical equipment used to raise and lower the Marmet Lock Stoney gate valve into the culvert system.

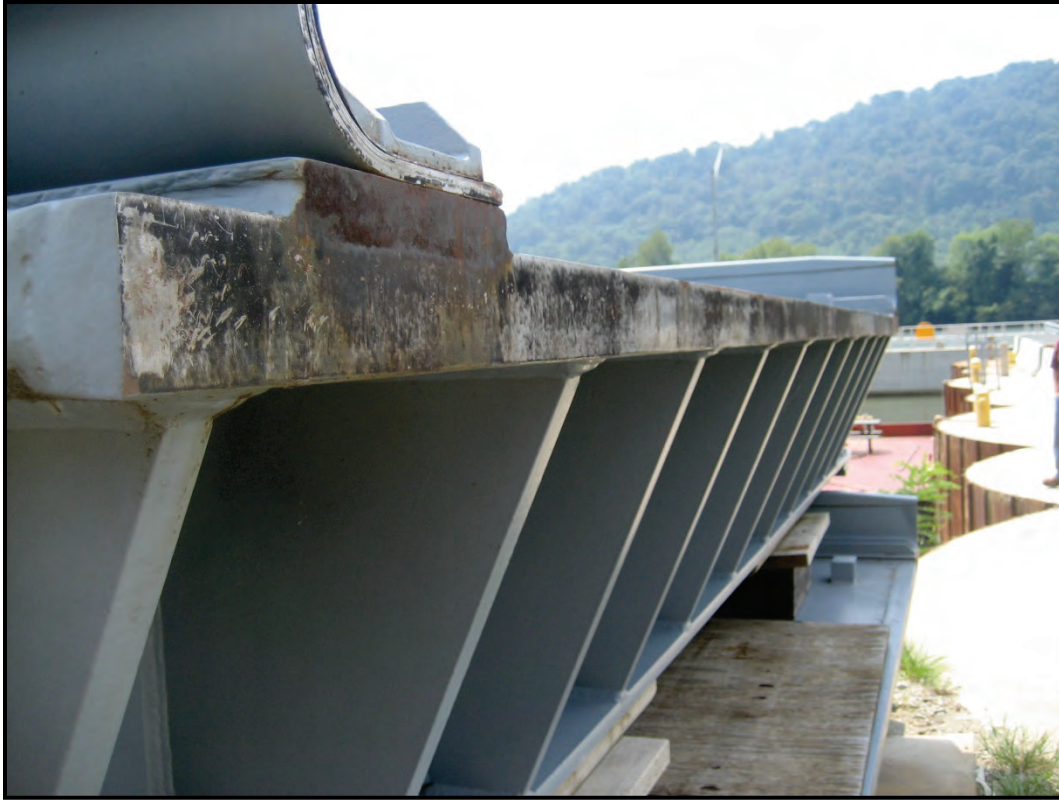
Figure 7. Machined seal on bottom of Stoney gate valve.

The inspections consisted of looking at the rollers on the sides of the valves, the machined seal on the bottom of the valve, and the seal embedded in the concrete floor of the culvert. Figure 7 shows the machined seal on the bottom of one of the spare Stoney gate valves. Each year of the monitoring program, a team consisting of researchers from the ERDC, engineers from LRH, and lock personnel would deploy the ROV and inspect the valves. Figure 13 shows the light of the ROV in the valve well as the inspection is being performed.

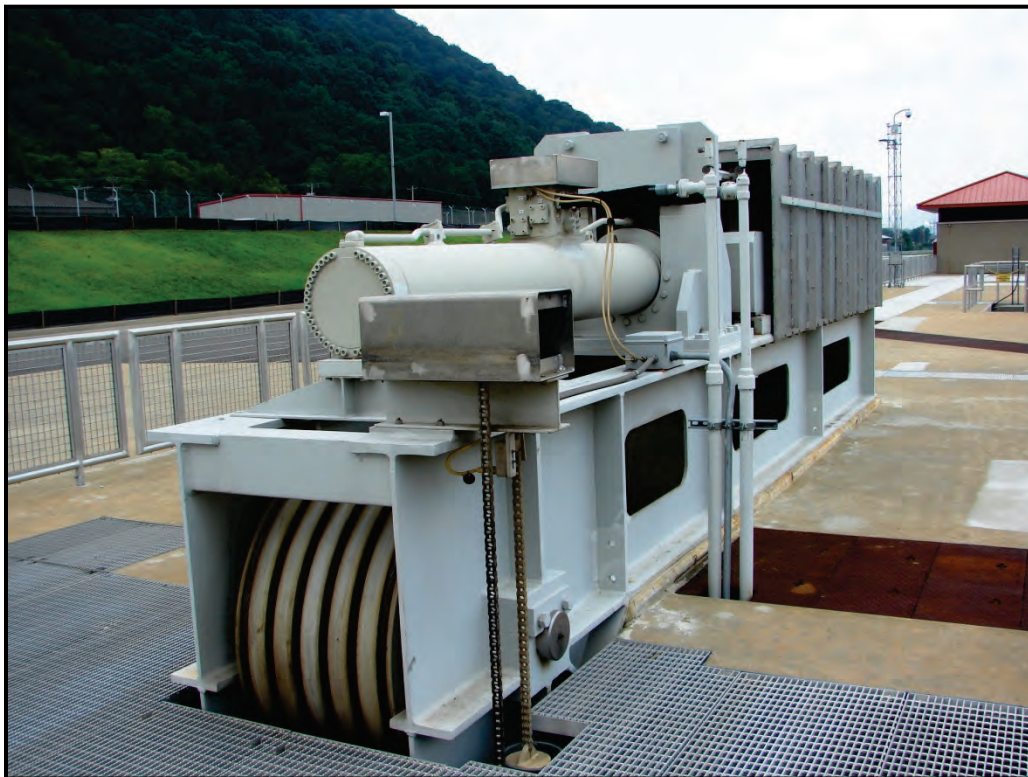
Figure 8. Mechanical equipment used to raise and lower Stoney gate valve into Marmet Lock filling and emptying culvert system.

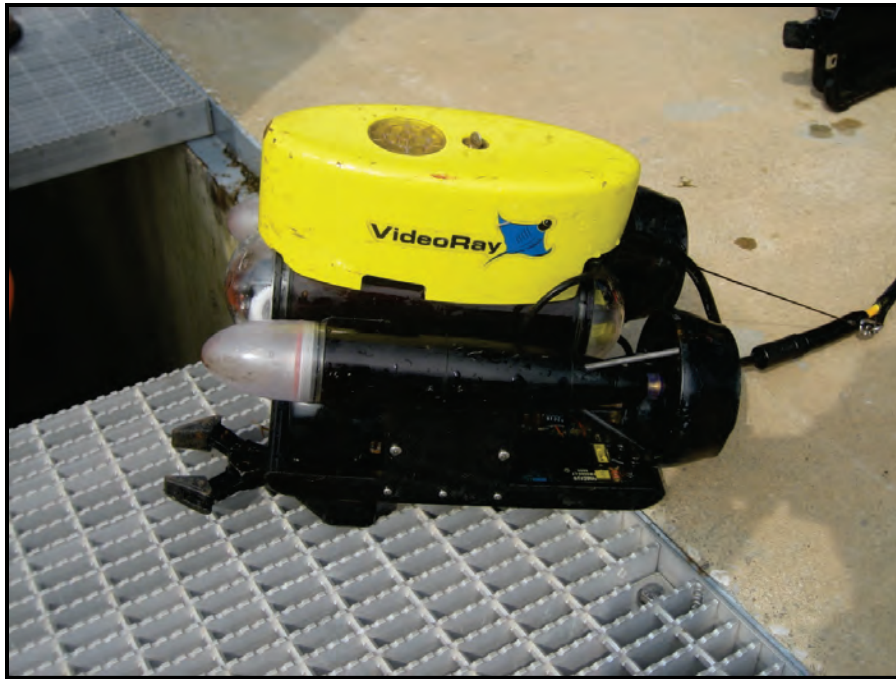
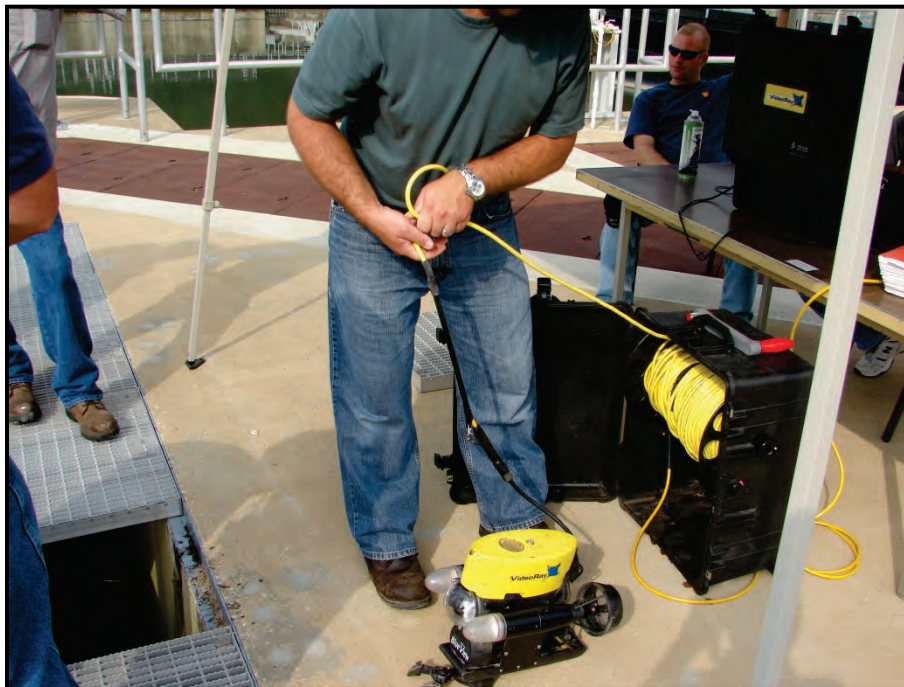
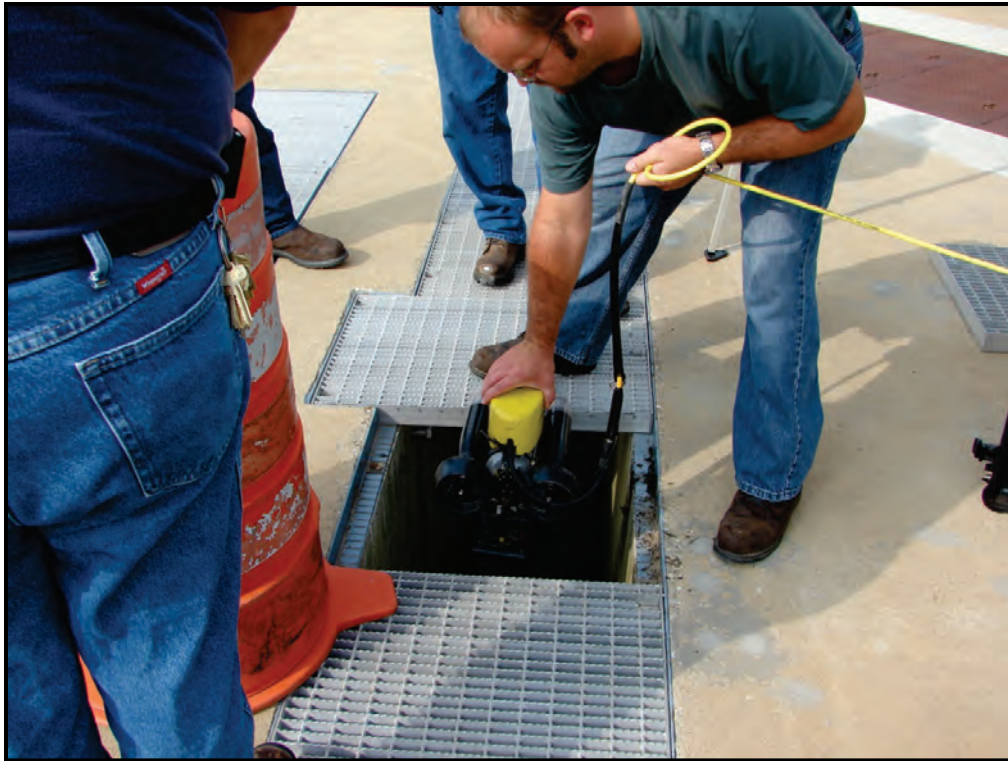
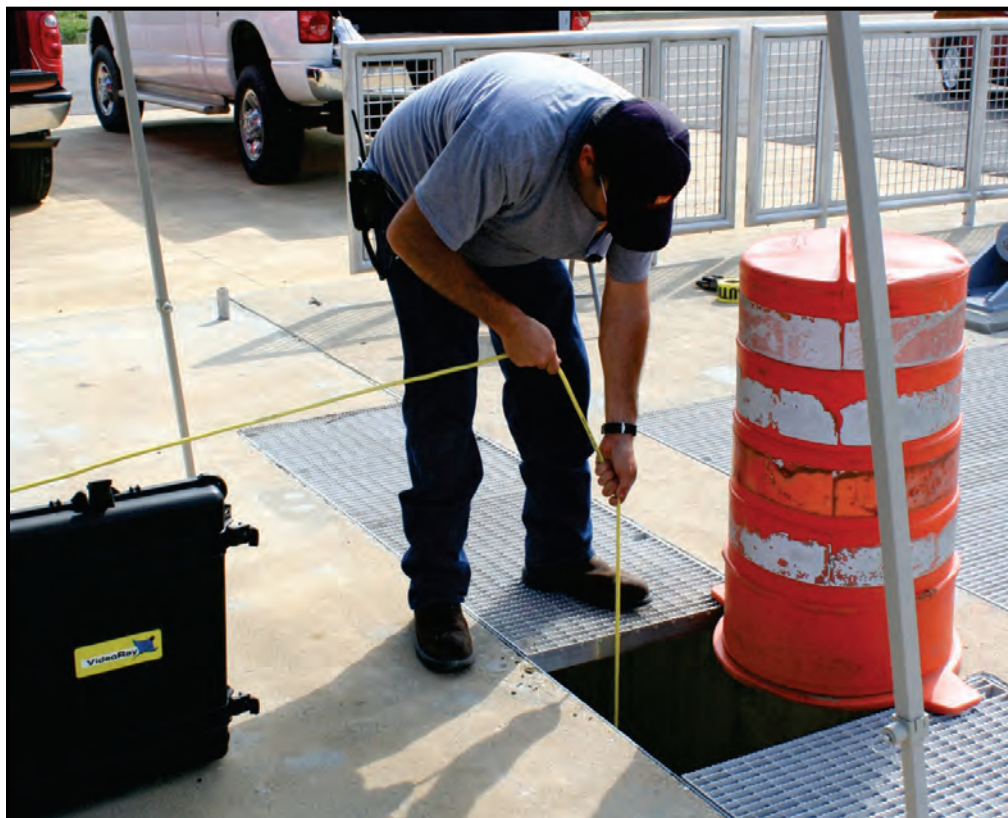
Figure 9. ROV used in Marmet Lock Stoney gate valves and culvert tunnels inspection.

Figure 10. ROV being attached to tether.

Figure 11. ROV entering valve well to Marmet Lock Stoney gate valves and culvert tunnels.

Figure 12. ROV being lowered to Marmet Lock Stoney gate valves and culvert tunnels.

The Stoney gate valves and interior walls of the culvert system were inspected using an ROV. Figures 9 through 12 show the ROV used for these inspections being deployed.

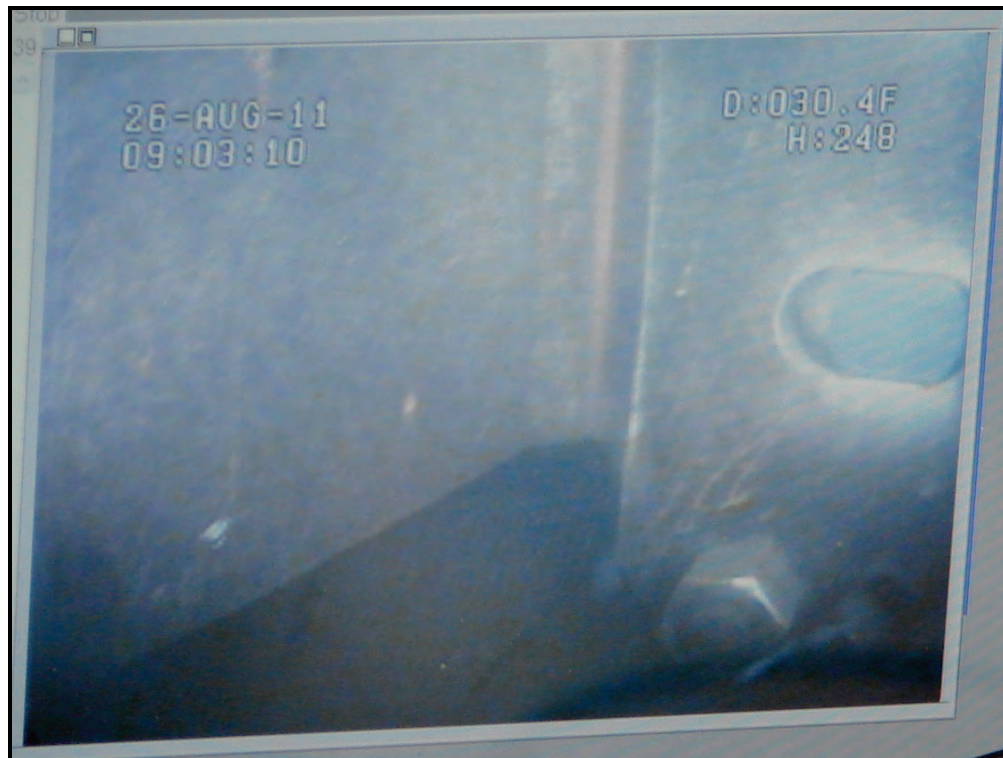
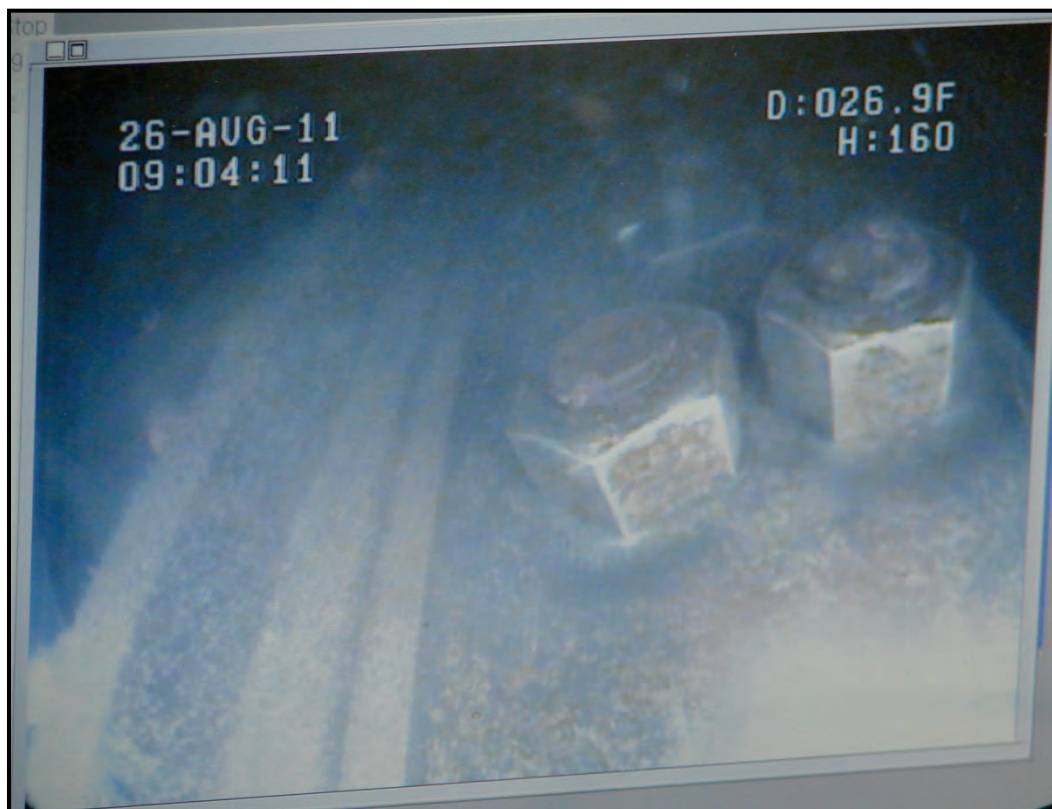
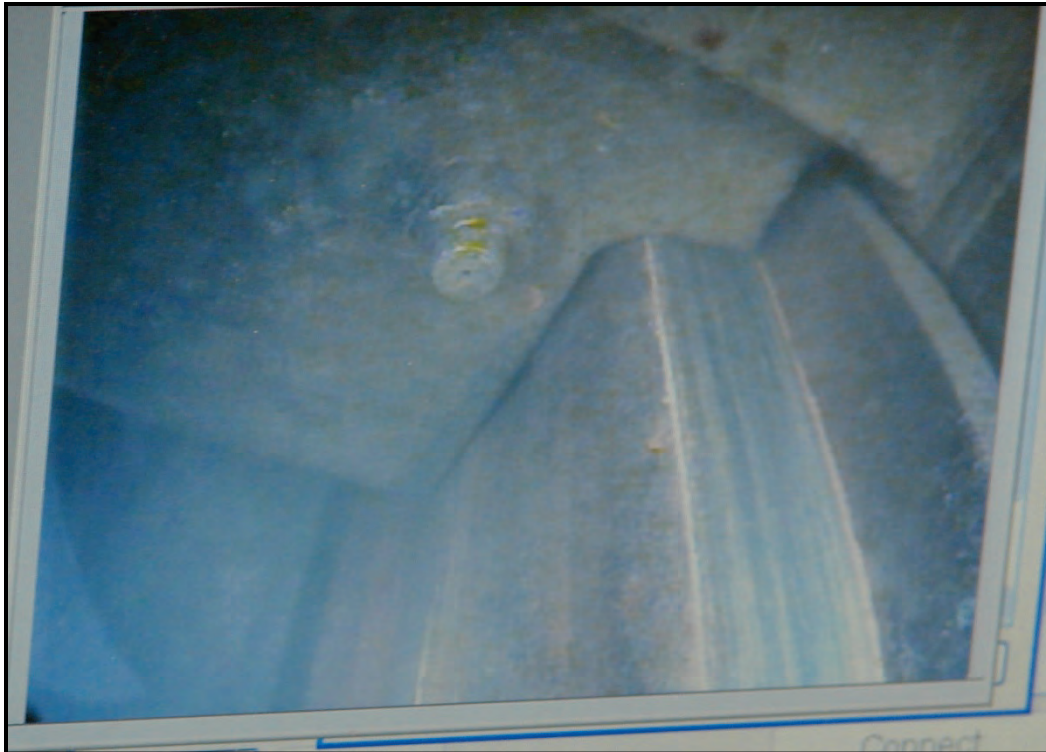
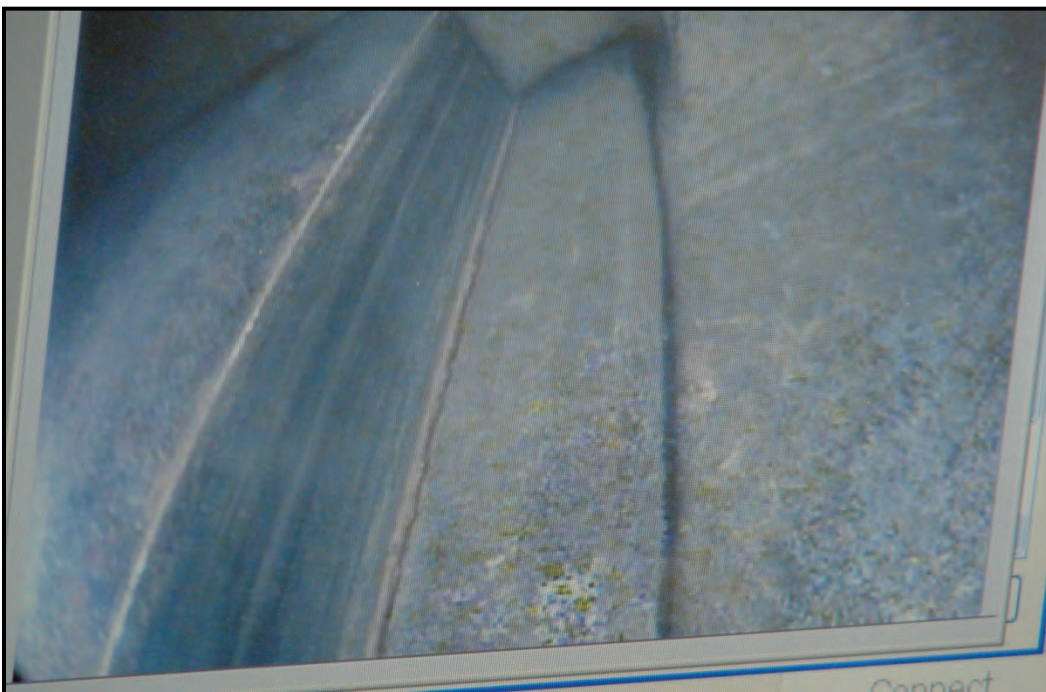
Figures 14 through 17 show typically representative photos of the Stoney gate valve inspection screen shots. Video of the inspections was also recorded and reviewed at a later date. After viewing the annual inspections and the videos, it was determined that the Stoney gate valves were performing well, and no cavitation or unusual wear has occurred at this time.

Figure 14. Representative photo of ROV inspecting Marmet Lock Stoney gate valve.

The Stoney gate valves are performing well and are not showing any signs of unusual wear.

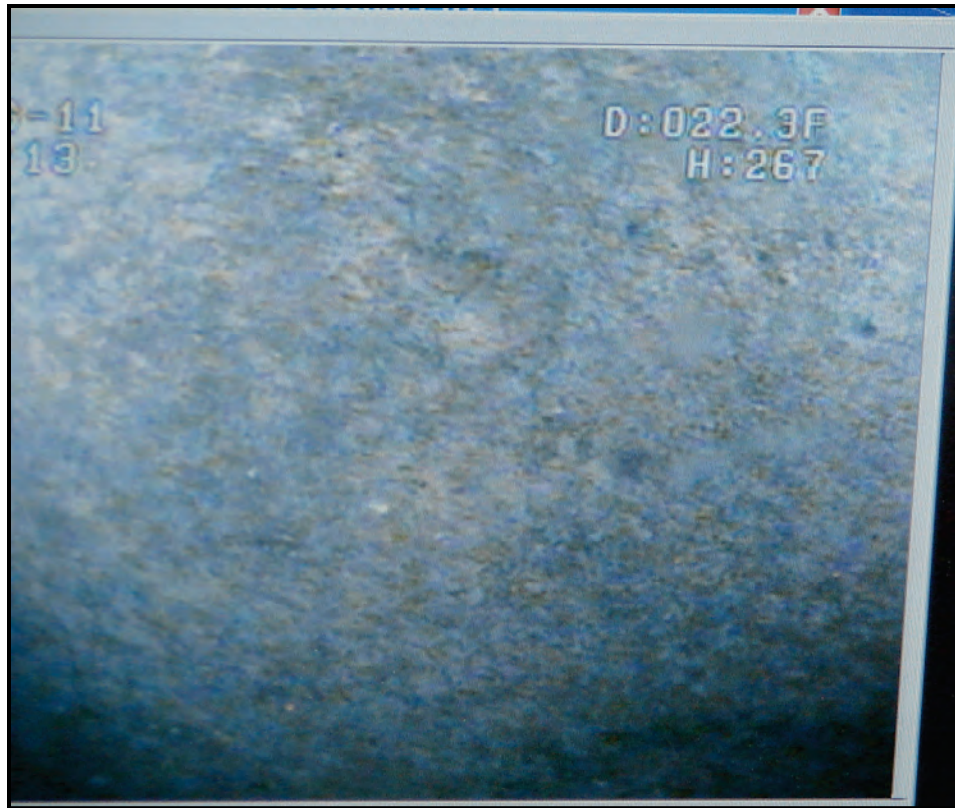
During the ROV inspections, the lock culverts and discharge outlets were also inspected. The ROV was maneuvered into the culverts downstream of the valves and into the discharge outlets to inspect the culvert walls. Some small pockets of erosion were discovered in the walls where small pieces of aggregate had eroded out of the concrete, but nothing substantial was noted (Figure 18). These localized areas of interest were further inspected by a dive team and confirmed to be of no concern regarding concrete deterioration. The walls of the culverts were overall in good condition.

Figure 18. Minor erosion of Marmet Lock culvert concrete wall, as indicated by ROV.

An ROV was maneuvered into the culverts downstream of the valves and into the discharge outlet to inspect the culvert walls. Some small pockets of erosion were discovered in the walls where small pieces of aggregate had eroded out of the concrete, but nothing substantial was noted. These localized areas of interest were further inspected by a dive team and

confirmed to be of no concern regarding concrete deterioration. The walls of the culverts were overall in good condition.

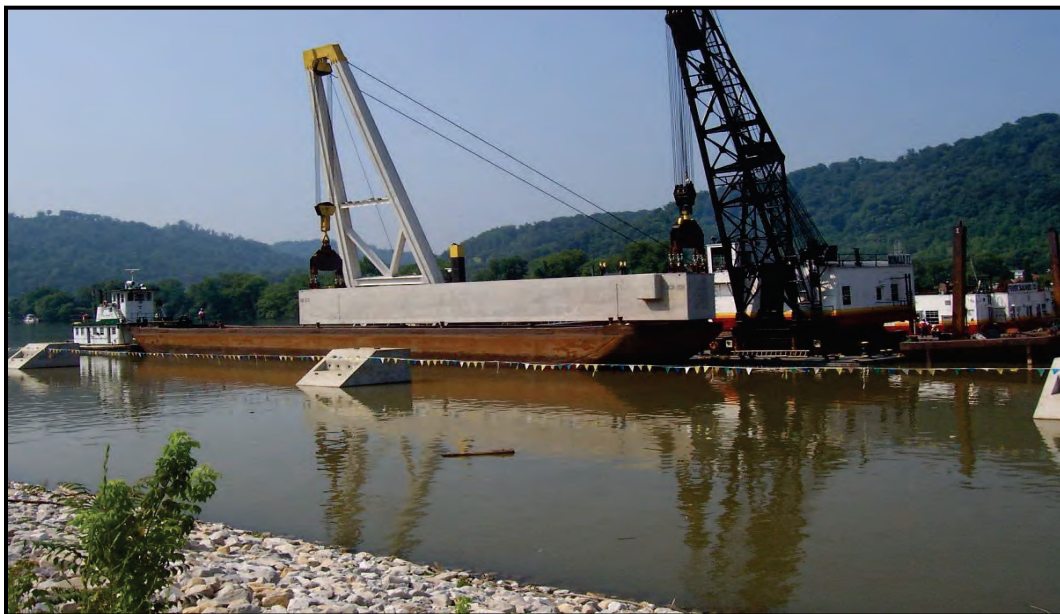
The new upstream guidewall at Marmet is innovative in design. It is a straight 1,600 ft long wall with steel wall armor for the tows to slide on. The wall consists of fourteen drilled shaft piers and a concrete-filled nose cell substructure supporting a superstructure of approximately fifteen, 500-tons-each (fifteen, 110 ft long), posttensioned concrete box beams. The fifteen, posttensioned, 10 ft by 10 ft concrete box beams were designed to withstand impact face punching shear for an extreme event impact load of 710 kips. At the same time, the structure had to be kept relatively thin walled so the beams could span 110 ft without being too heavy to lift into place with regionally available equipment. Figure 20 shows a section of the wall being placed.

Figure 20. Section of new Marmet upstream guide wall being placed.

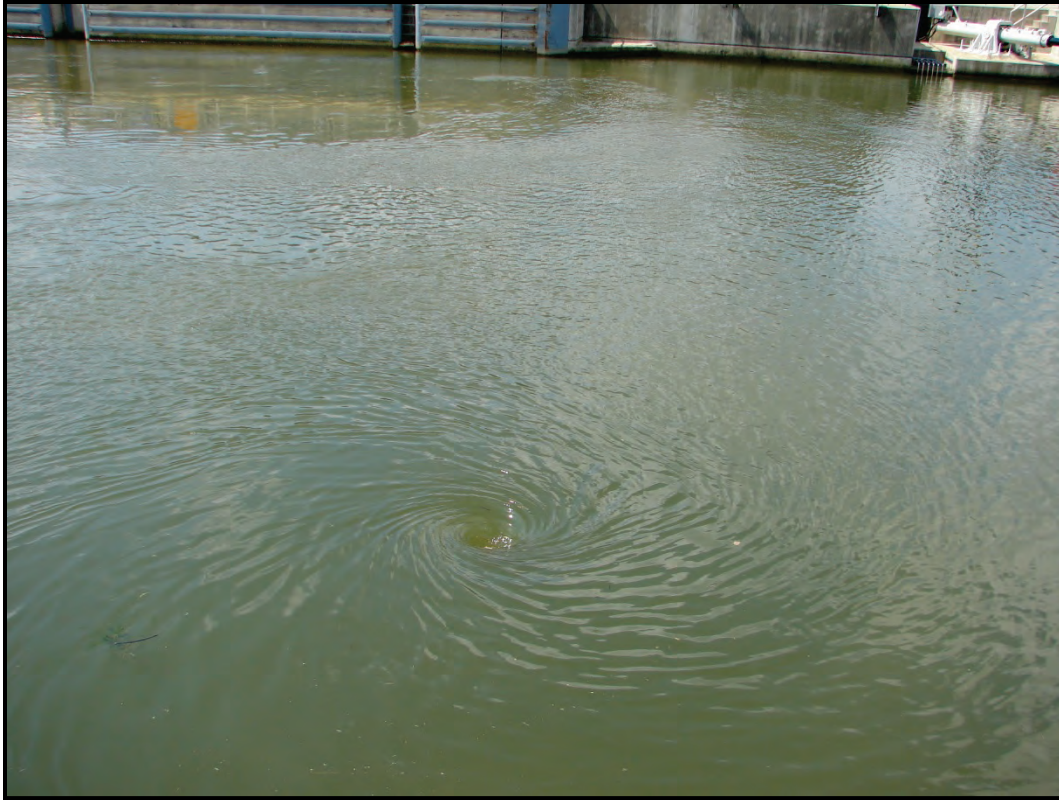
Figure 26. Minimal vortex formation outside the upper miter gate during filling.

Vortex formation outside the upstream miter gate during filling was minimal and not a hazard to navigation. Similarly, the turbulence created outside the lower miter gate during emptying appeared to be normal when compared to other locks with similar lock-emptying discharge ports.

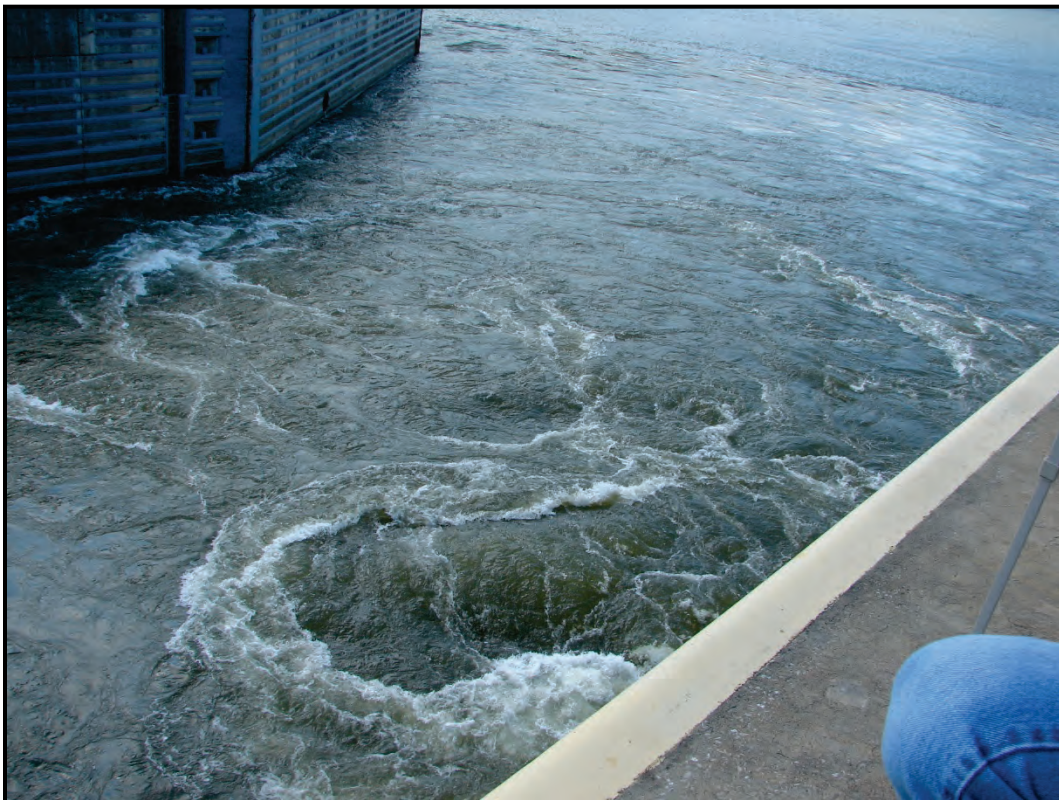
Figure 27. Typical turbulent conditions at downstream end of lock during lock emptying.
